Installation Instructions

E40-59-004-01-10

Vehicle
15-17 Lexus IS200T
18+ Lexus IS300
14+ Lexus IS350

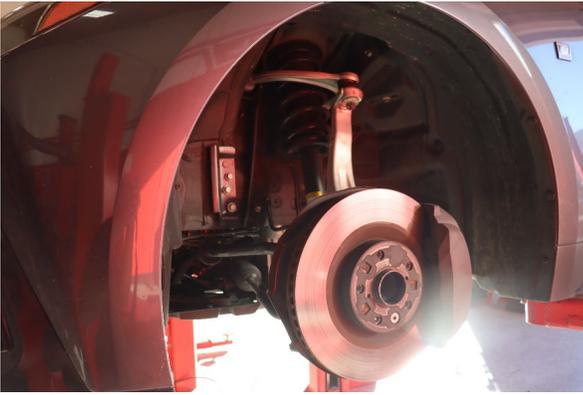
1. Safely lift vehicle and remove the front wheels.

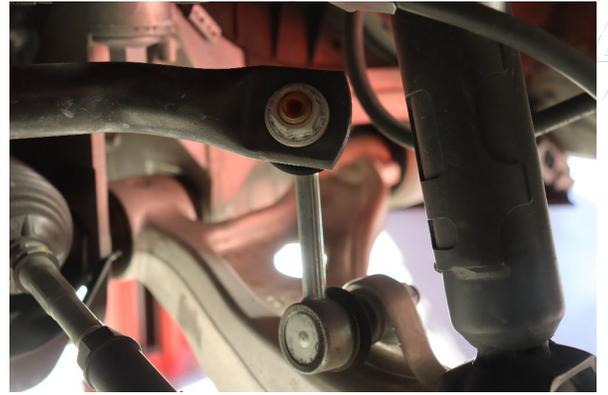
2. Remove the endlink nut with a 17mm socket.

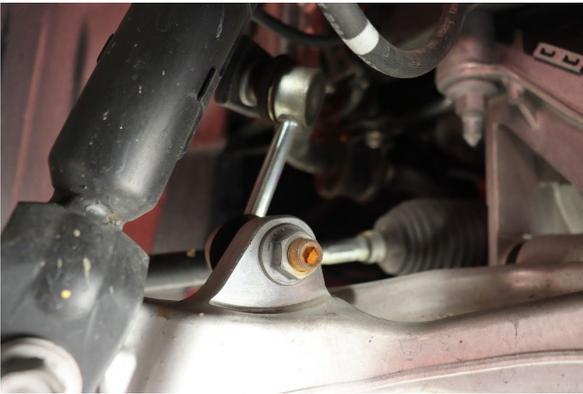
3. Loosen the nut (towards the rear of the vehicle) with a 17mm socket.

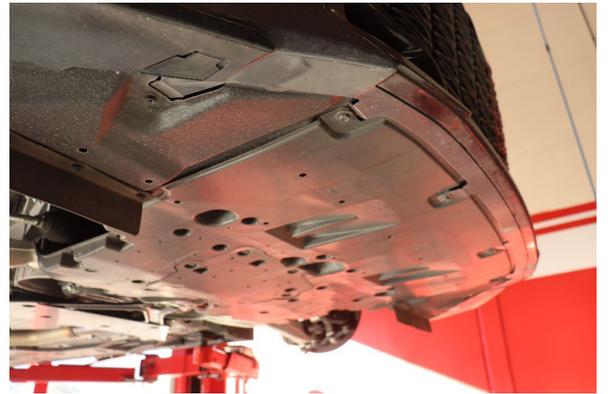
4. Remove the under tray with a 10mm socket and clip pleyer to remove the plastic rivets.

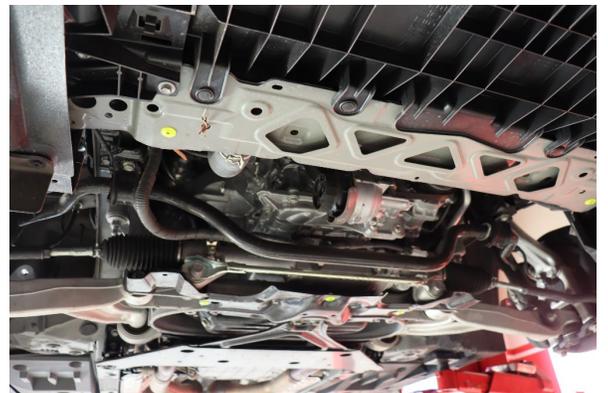
6. Loosen and Remove the OE sway bar brackets. With a 14mm socket

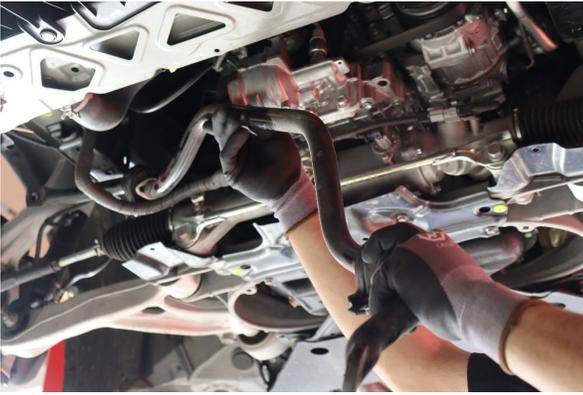
Remove the OE sway bar.

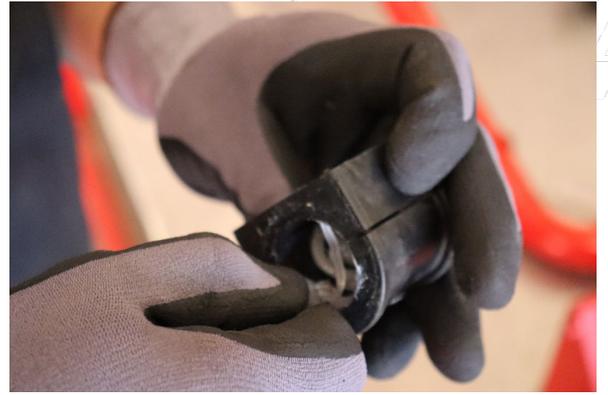
Apply lubricant to the provided Eibach sway bar bushings

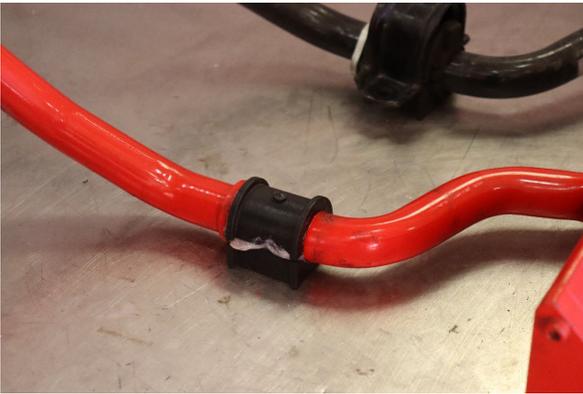
Install the bushings and brackets in the position as shown.

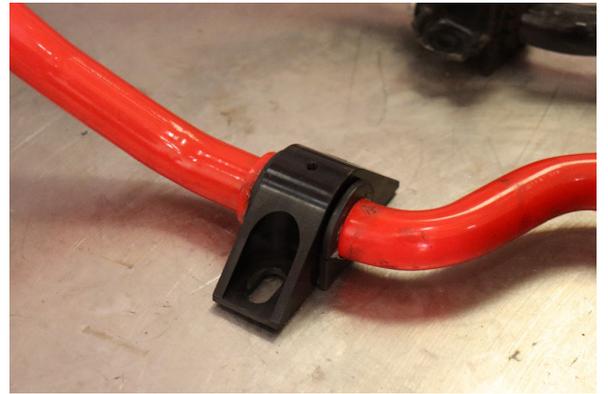
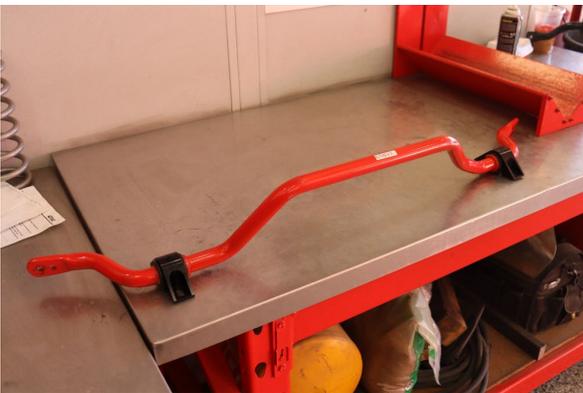
Install the Eibach sway bar.

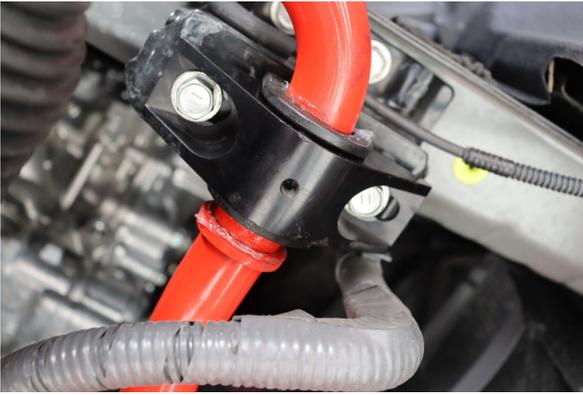
Using the OE bolts mount the Eibach bracket to the subframe.

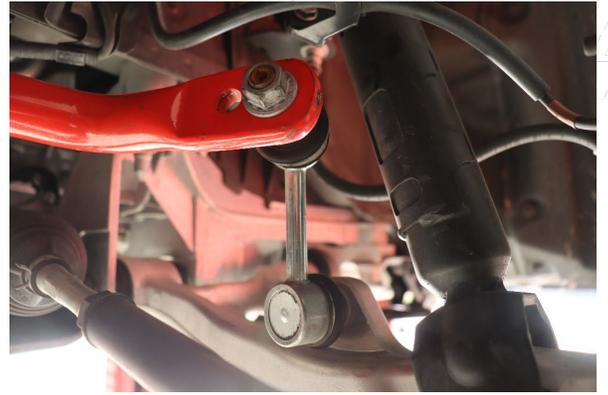
Install the OE end link to the Eibach sway bar.

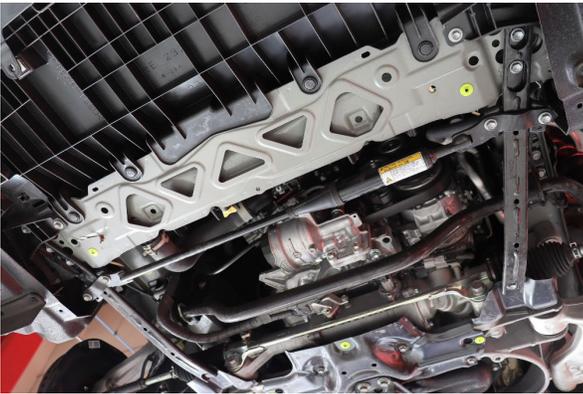
Reinstall the subframe reinforcement braces.

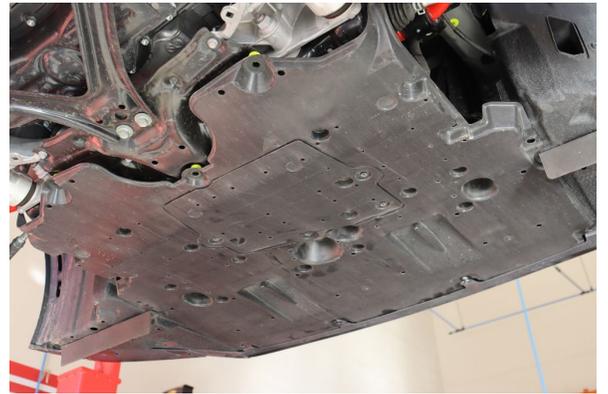
Reinstall the plastic undertray.
